Address: 3521 TANGLEWOOD Place

Report # DUGAN-013108

3521 Tanglewood Pl.
Anchorage, Alaska 99517

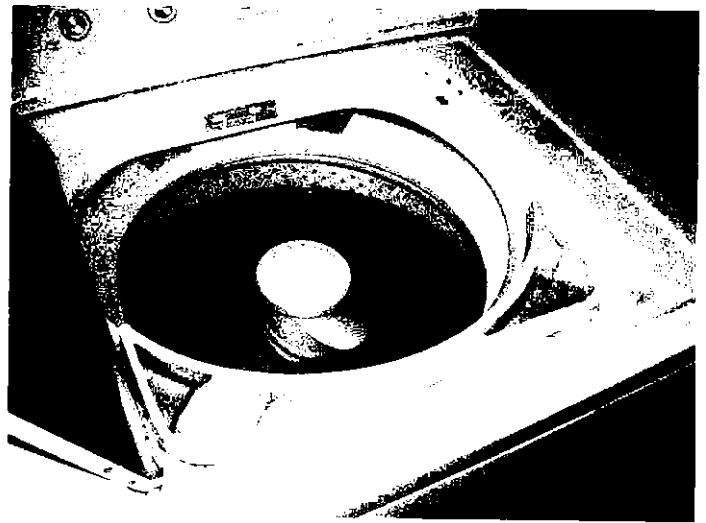
The washer was full of water at the time of inspection. It does not appear the washer is operational.

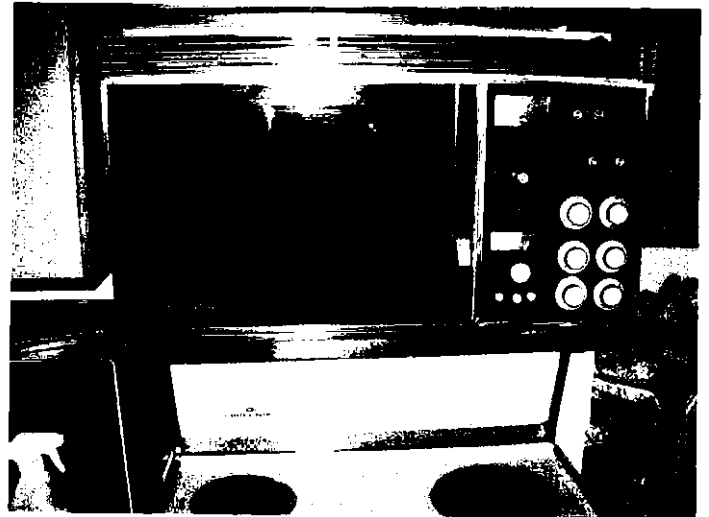
Unit #2 - Kitchen—Exhaust Vent Fan—The exhaust vent fan above the range was not operating at the time of inspection. Recommend repairing or replacing the exhaust vent fan.

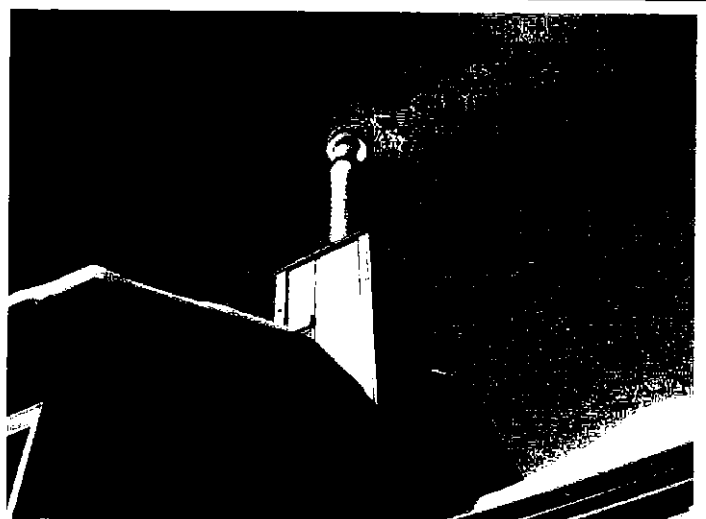
Roof - Boiler Flue Chase - No Flashing - There is no flashing at the top of the boiler flue chase, at the Southeast portion of the roof. Recommend a licensed roofing contractor evaluate the boiler flue chase, making all necessary repairs.

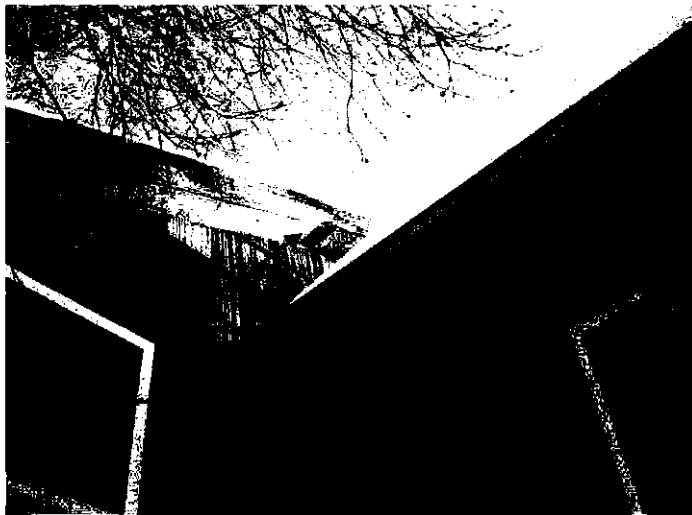
Roof Eave - West - There is an opening in the soffit, under the West upper roof eave. This condition will allow animals and insects access to the structure. Recommend sealing this opening, under the West roof eave.

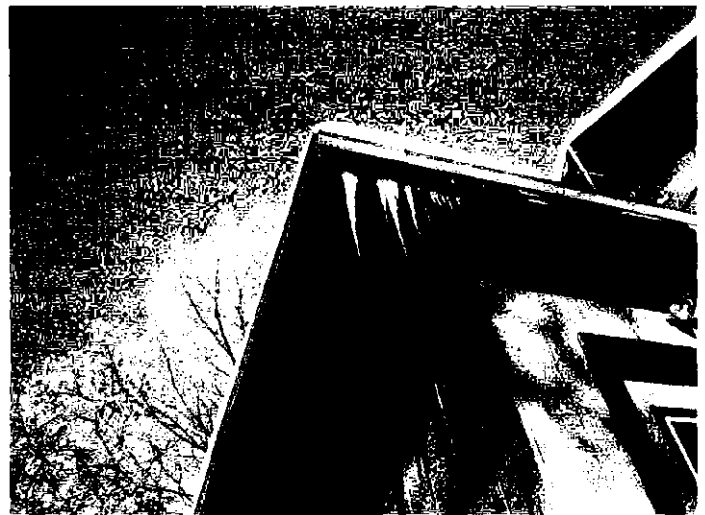
Roof - West Artic Entryway - Water is draining from the flat roof, between the flashing and the fascia, at the Southwest corner. Recommend a licensed roofing contractor evaluate the flashing, at the West artic entryway roof eave, making all necessary repairs.

8. Roof-West Arctic Entry way: Repair flashing southwest corner.
9. Arctic Entry Way-West Side: Repair roof leak causing water stains on vapor barrier. Not responsible for replacement of damaged plywood.
