Address: 4026 PARSONS Avenue

Listing #	08-7398	Price-List	\$ 180,000
Status	Active	Near	Anchorage
Zip Code	99508	Type	Multi-Family
Beds	8	Baths	4.00
Acres	0.14	Bldgs-Ttl #	1
Carport	0	Garage	0
Units-Ttl #	4	Prkg Spcs	4
Latitude	61.229336	Longitude	-149.805401
Year Built	1971	Income-Gross Annual

Recommendation Page 4026 Parsons, Anchorage

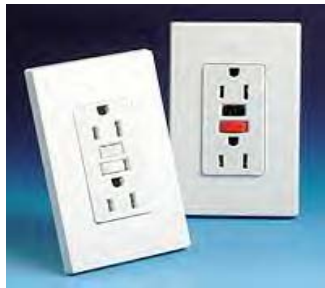
Ground Fault Circuit Interrupters (GFCI's)

A Ground Fault Circuit Interrupter outlet (also referred to as GFCI or GFI) is a device that protects you from an electric shock. These outlets and/or the circuits that they protect, should be found in all readily accessible kitchen countertop,

garage, bathroom, exterior, and any below-grade outlets in a crawlspace. GFCI outlets do operate on older electrical

systems where there is no ground wire present. Knowledgeable consumers familiar with electrical wiring practices who also follow the instructions accompanying the device, may install receptacle-type GFCI's with little difficulty. Some homes are equipped with circuit breaker type GFCI's and these will protect every outlet installed downstream from this breaker. A licensed electrician should be consulted for installation. Manufacturers of GFCI devices state that the GFCI outlets should be tested at least once a month to ensure proper function ability.
